COSTS OF REMEDIATION AT MINE SITES

April 1998

U.S. Environmental Protection Agency
Office of Solid Waste
401 M Street, SW
Washington, DC 20460

This technical background document, *Costs of Remediation at Mine Sites*, was submitted for public review to EPA's RCRA Docket #F-97-2P4P-FFFFF. It provides supplementary information and support for the May 12, 1997 Supplemental Proposed Rule, *Land Disposal Restrictions Phase IV; Second Supplemental Proposal on Treatment Standards for Metal Wastes and Mineral Processing Wastes, Mineral Processing and Bevill Exclusion Issues, and the Use of Hazardous Waste as Fill* (62 FR 26041). The Agency has received comments from the public on this document and has listed these comments and Agency responses in the final section of the document. The Agency finalizes this document as of April 1998 and submits it to RCRA Docket # F-98-2P4F-FFFFF to provide supplementary information and support for the April 1998 Final Rule, *Land Disposal Restrictions Phase IV: Final Rule Promulgating Treatment Standards for Metal Wastes and Mineral Processing Wastes; Mineral Processing Secondary Materials and Bevill Exclusion Issues; Treatment Standards for Hazardous So

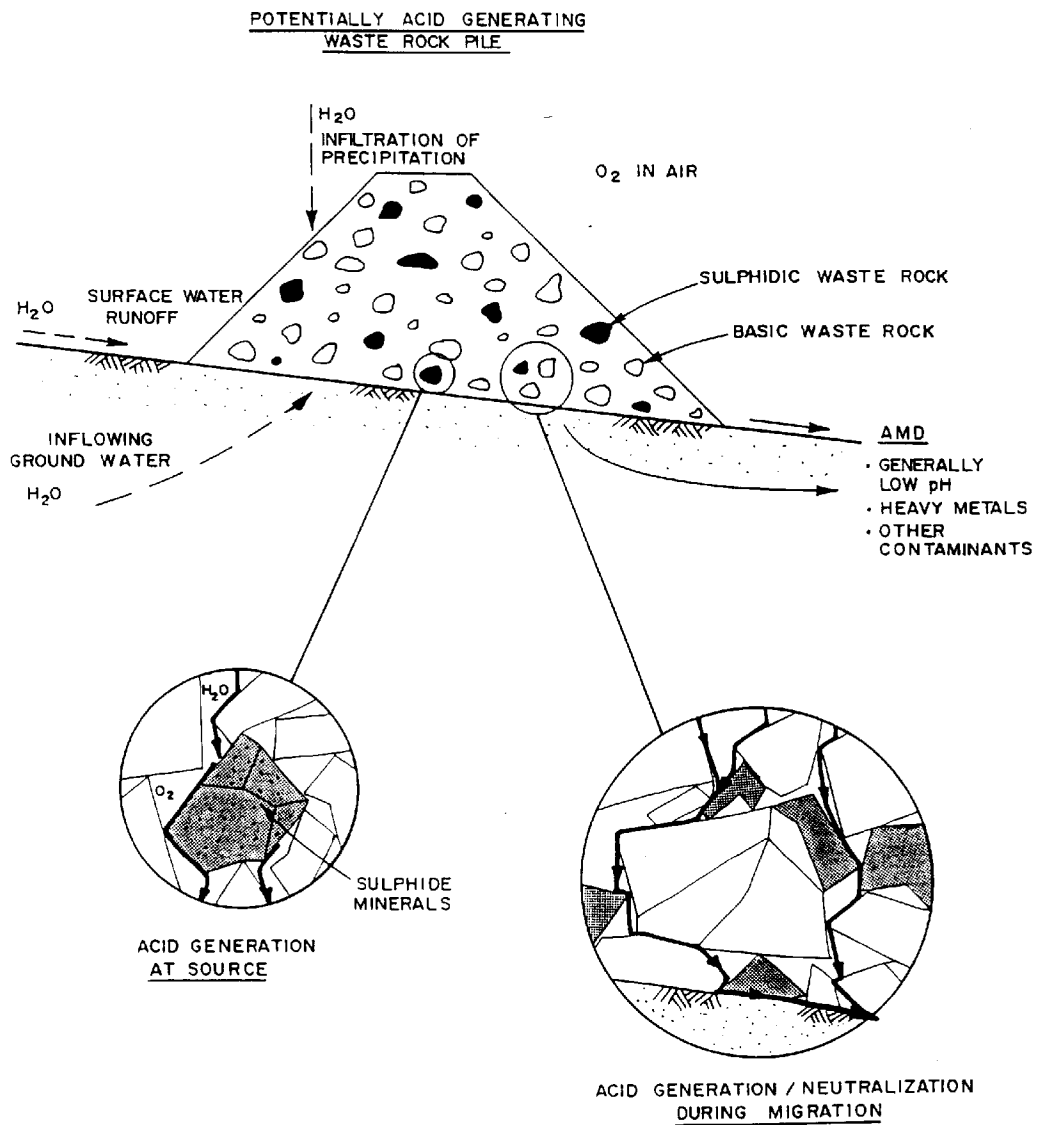
If ARD is not controlled, it can pose a threat to the environment due to the toxicity of heavy metals and other pollutants. Figure 2-1

Figure 2-1. Schematic Showing Concept of Acid Generation and AMD Migration.

(Steffen, Robertson, and Kirsten, 1989) presents a conceptual schematic of acid generation and migration through a waste rock pile. The process involves the sulfide-containing and basic rock present in the pile, the potential sources of oxygen and water, and the acid generation/neutralization occurring where these elements are in contact. This figure illustrates water percolating through the dump, coming into contact with both acid-generating and -neutralizing materials, and emerging from the ore as ARD.
